Use of CT in Detection of Internal Damage and Repair and Determination of Authenticity in High-Quality Bowed Stringed Instruments¹

Steven A. Sirr, MD John R. Waddle, Luthier

RadioGraphics 1999; 19:639-646

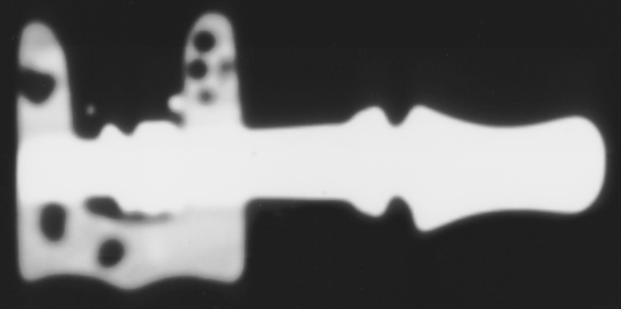
3.

Figures 3, 4. (3) High-resolution transaxial CT scan of a valuable violin reveals a network of wormholes in the peg box. The high-attenuation structure is an ebony peg. (4) High-resolution transaxial CT scan of a Venetian cello demonstrates a network of wormholes (arrow) in the scroll. A small amount of glue is seen at the edge of the scroll (arrowhead).

Varying degrees of damage or repair were detected in all 17 instruments. CT demonstrated damage from worm infestation in two violins and one cello (Figs 3, 4). An air gap between the rib and an internal corner block was detected in a Stradivarius violin (Fig 5). Plastic deformity of wood was detected in five instruments. Figure 6 illustrates deformity of the spruce front plate and ebony fingerboard of a Stradivarius violin.

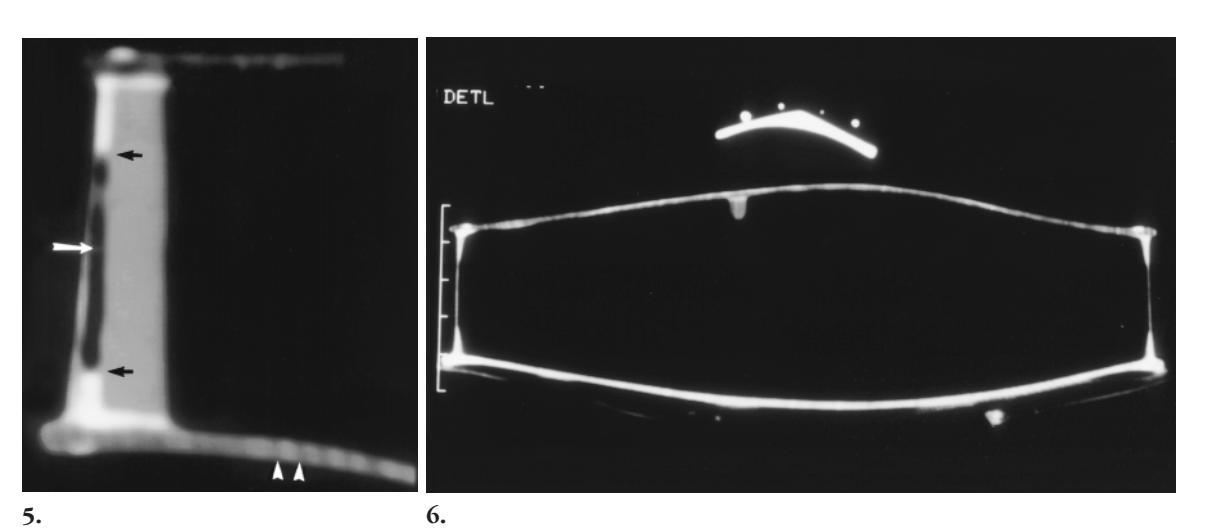
Figures 5, 6. (5) High-resolution transaxial CT scan of a Stradivarius violin shows an air gap (white arrow) between the rib and an internal corner block. Note the two air-glue interfaces between the inner surface of the rib and the inner corner block (black arrows). Arrowheads indicate the back plate. (6) High-resolution transaxial CT scan of the front plate of a very old and valuable Stradivarius violin shows mild, asymmetric plastic deformity of the front plate and tilting deformity of the ebony fingerboard.

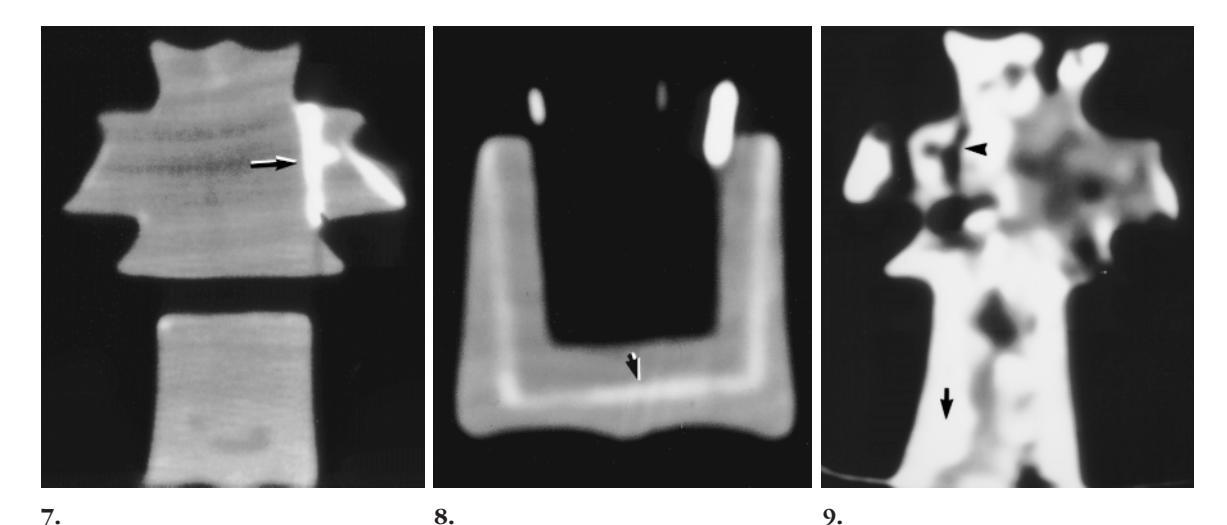
Figures 7–9. (7) High-resolution transaxial CT scan of the scroll of an old and valuable Italian violin shows a linear region of high attenuation (arrow), consistent with glue repair. (8) High-resolution transaxial CT scan of the peg box of a valuable violin shows a linear area of high attenuation that represents glue repair (arrow). (9) High-resolution transaxial CT scan of the scroll of an old Italian violin demonstrates wormholes (arrowhead) and high-attenuation filler material (arrow) occupying a large volume of the scroll. Multiple wormholes several millimeters in diameter were visible on the surface of the scroll. An expert luthier had painted a wood grain pattern on the surface to conceal the filler material.

Cracks repaired with animal glue were detected in all instruments (Figs 7, 8). High-attenuation filler material nearly completely replaced the scroll in one Italian violin (Fig 9).

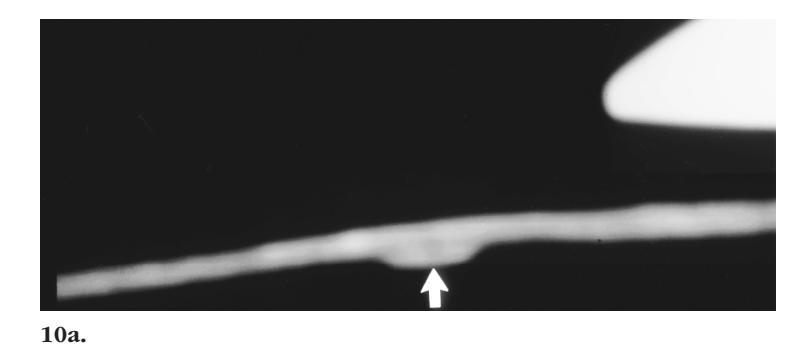
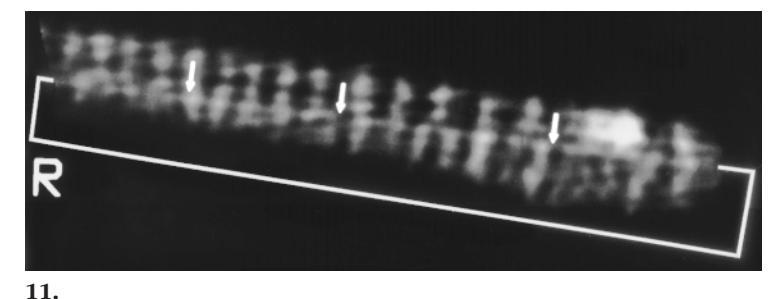
10b.

Figures 10, 11. (10a) High-resolution transaxial CT scan of a Stradivarius violin shows a wooden cleat (arrow) glued to the inside surface of the front plate. (10b) High-resolution coronal CT scan of the front plate shows multiple wooden cleats (arrowheads) and the large, round wooden patch (open straight arrow), which involves almost the entire middle bout of the violin. Note the relationship between the f-holes, the bass bar (solid curved arrow), the sound post (solid straight arrow), and the foot of the bridge distal to the sound post (open curved arrow). (11) High-resolution transaxial CT scan of the front plate of a high-quality Venetian cello shows the typical appearance of an internal wooden patch (bracket) and its interface with the original front plate (arrows). Note the discontinuity between the grain pattern of the original front plate and that of the embedded wooden patch. This patch occupied nearly 50% of the thickness of the original front plate.

In addition, wooden patches or cleats were detected in all instruments. Figure 10 shows the transaxial and coronal CT appearance of cleats in a Stradivarius violin. The characteristic CT appearance of discontinuity between the

grain lines of the original wood and those of an internal wooden patch embedded in the front plate of a Venetian cello is shown in Figure 11. Figure 12 demonstrates an internal wooden patch embedded in the front plate of a violin. The internal wood grain patterns in the scrolls of a Stradivarius violin and a Venetian cello are shown in Figure 13.

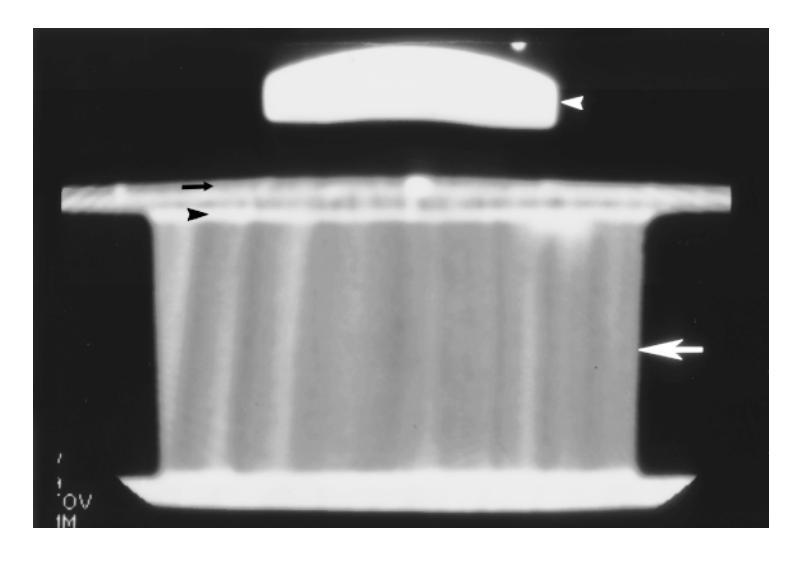
Figure 12. High-resolution transaxial CT scan of a violin demonstrates an internal wooden patch (black arrowhead) positioned between an internal block (white arrow) and the front plate (black arrow). Note the discontinuity between the grain pattern of the newer wooden patch and that of the original front plate. The ebony fingerboard (white arrowhead) has high attenuation.

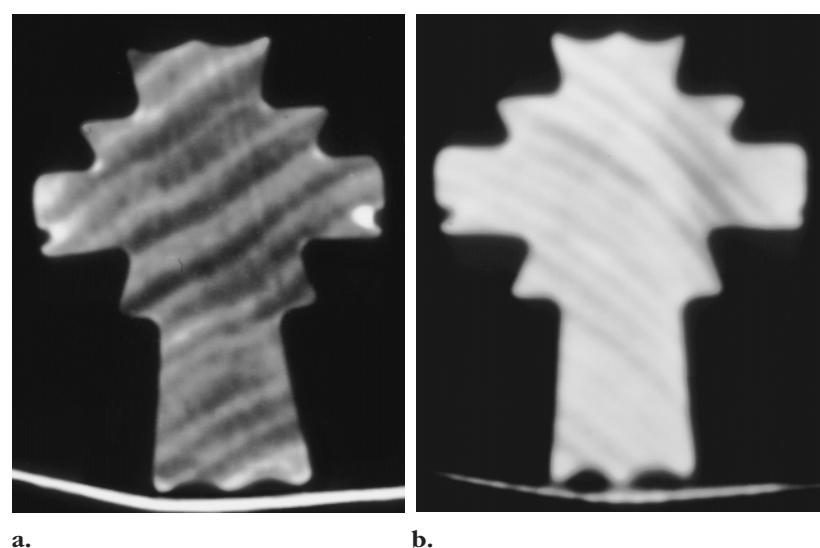
a.

Figure 13. High-resolution transaxial CT scans of the scrolls of a valuable Stradivarius violin (a) and Venetian cello (b) demonstrate internal wood grain patterns unique to these instruments. Such a pattern serves as a "fingerprint" that cannot be altered and enables an instrument to be identified with absolute certainty.
